SERVICE BULLETIN

TS-930S 15 METER INTERNAL BEAT TONE

1-27-84

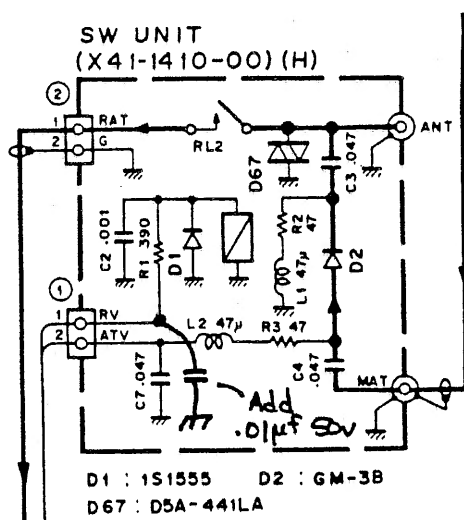
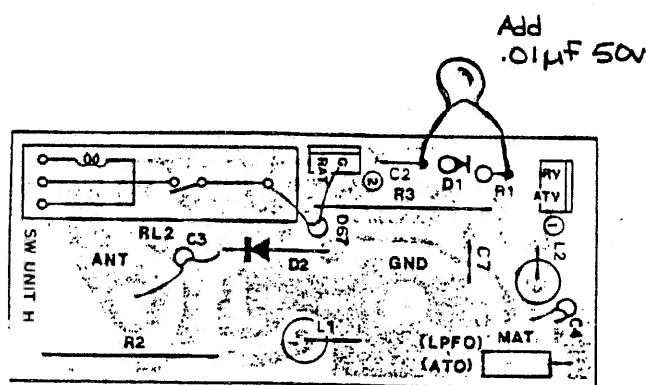
Some users have reported an internal beat tone that appears every 10 KHz, when operating in the range of 20-21.5 Mhz. Apparently the RV terminal of Switch Unit H is being affected by the 1st loop of the PLL unit. The cure is relatively simple. Add a .01 uf 50v disc ceramic capacitor on the RV line of Switch Unit H as shown below.
